Auckland Coastal Zone Geology & Geomorphology

Professor Michael Petterson & Graham Hinchliffe
with Data from Chloe Samaratunga

Geomorphology of Auckland Coastline

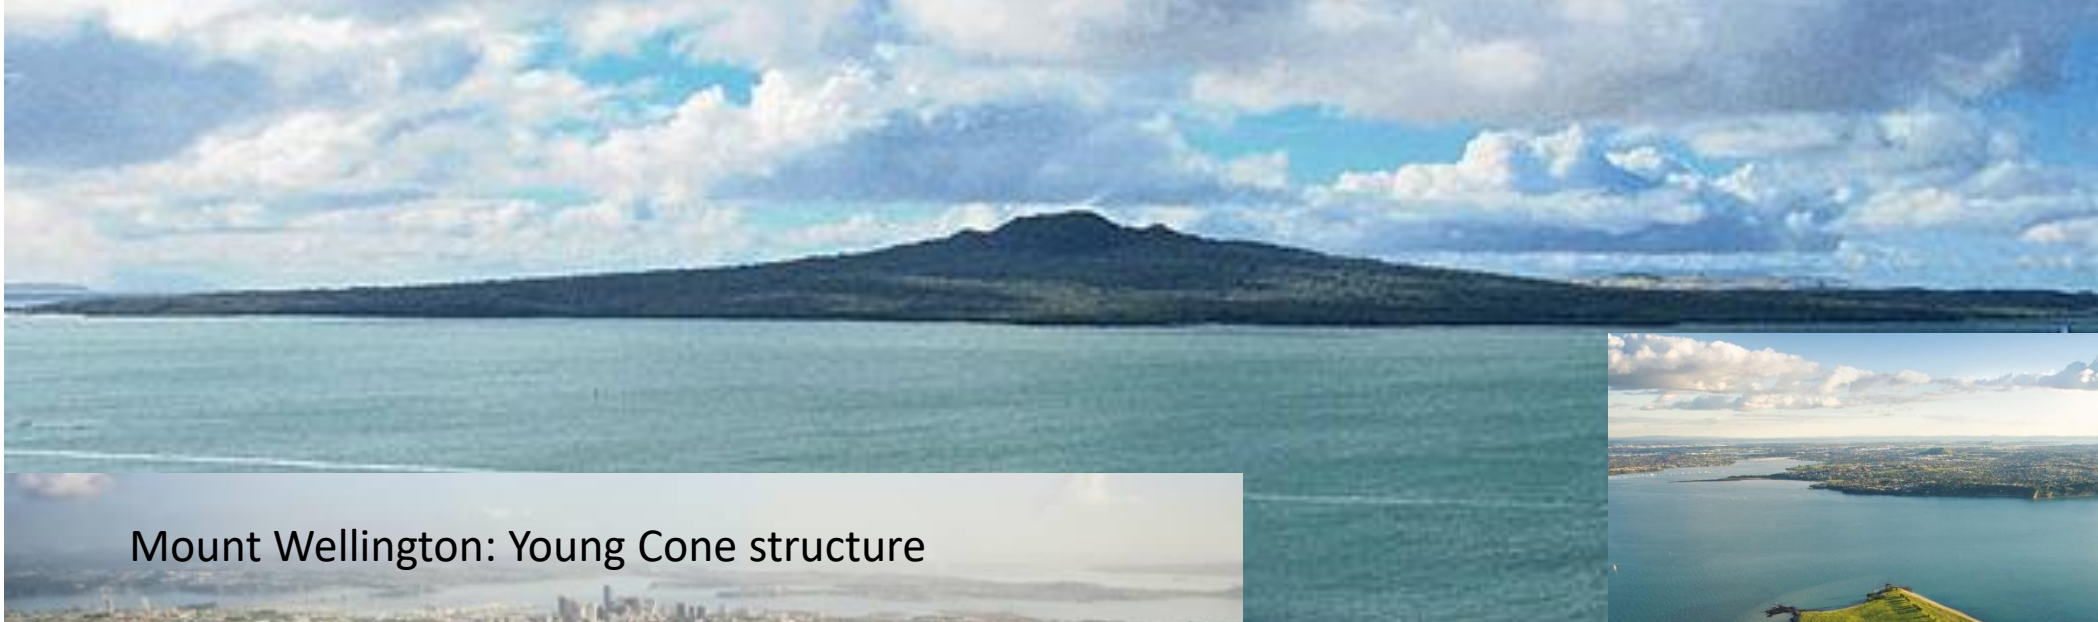
Rangitoto: Classic shield volcano

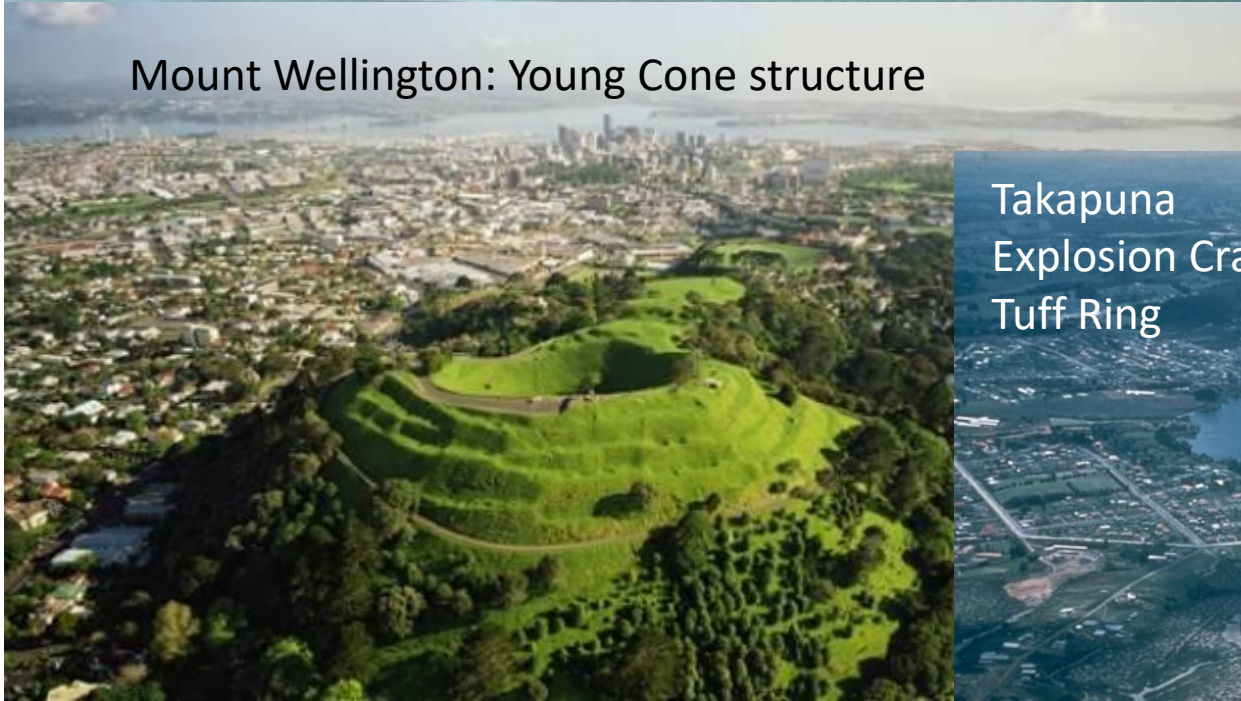
Mount Wellington: Young Cone structure

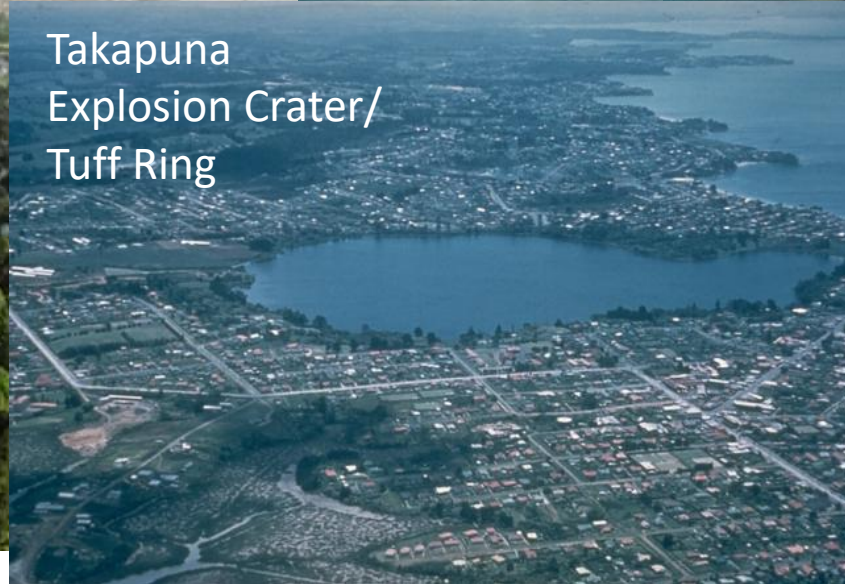
Takapuna
Explosion Crater/
Tuff Ring

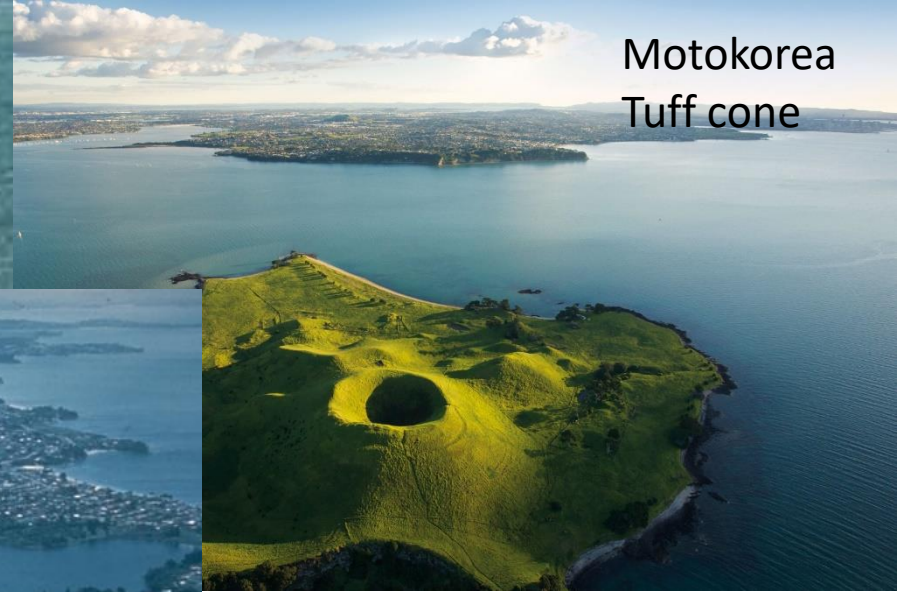
Motokorea
Tuff cone

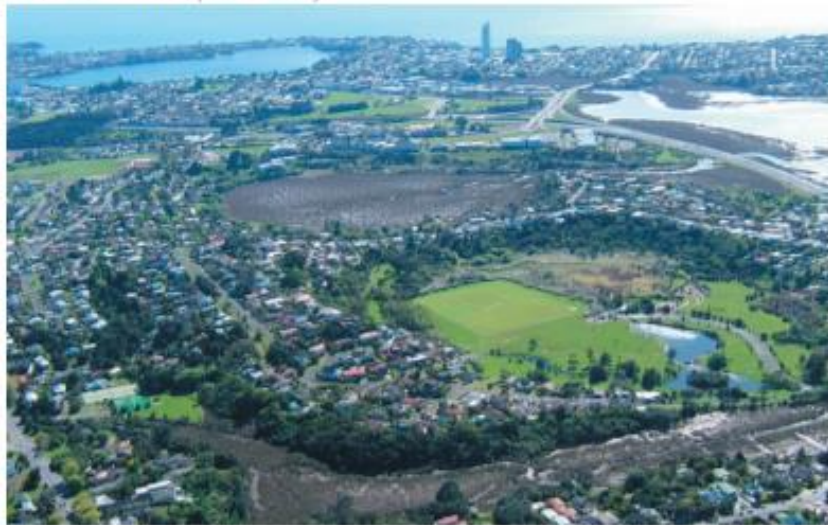
37 (left). Drowned explosion craters

Some of the explosion craters of the Auckland Volcanic Field have been inundated by the sea. Of the 3 explosion craters on Auckland's North Shore, only Tank Farm (centre) remains in a largely pristine state. Onepoto Basin (grassy fields, lower right) has been reclaimed and Pupuke (upper left) is a freshwater lake, not invaded by the adjacent Waitemata Harbour.

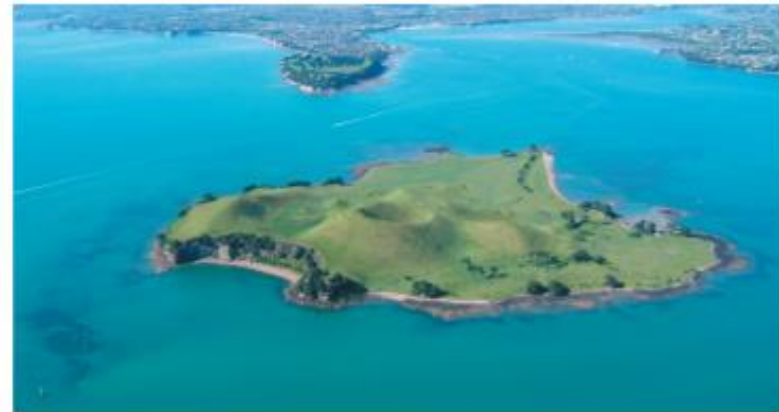
38 (above). Drowned volcanoes

Motukorea (Browns Island), in Auckland's Waitemata Harbour, was erupted onto dry land during the Last Ice Age when sea level was lower. It is now an island at the entrance to Tamaki Estuary (top right of photo) and is being eroded by the sea.

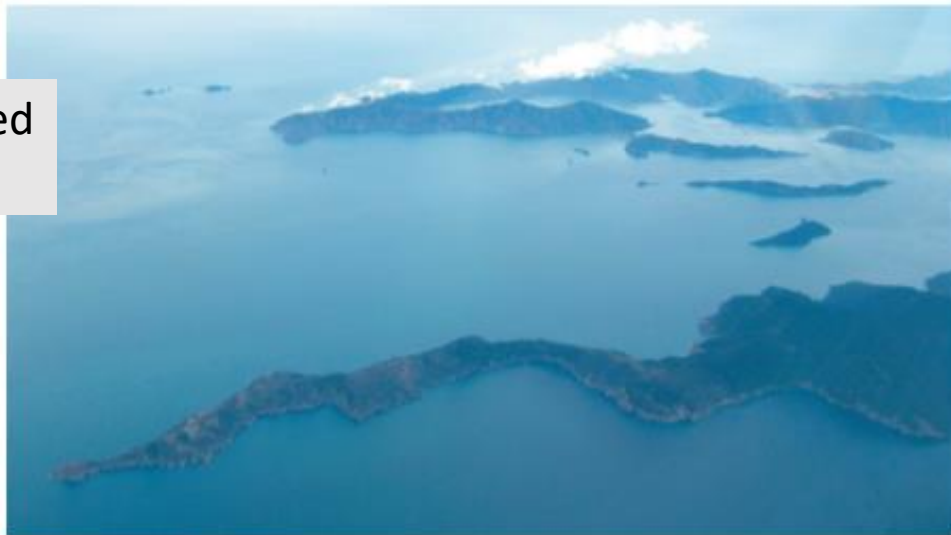
39. Drowned ridge crests

Cape Jackson forms the northern extremity of a long, sinuous drowned ridge line jutting into Cook Strait between Queen Charlotte Sound and Port Gore, Marlborough Sounds. Other drowned ridges are visible in the distance, including spindle-shaped Long Island in mid-channel (right side of photo) and the large V-shaped Arapawa Island beyond.

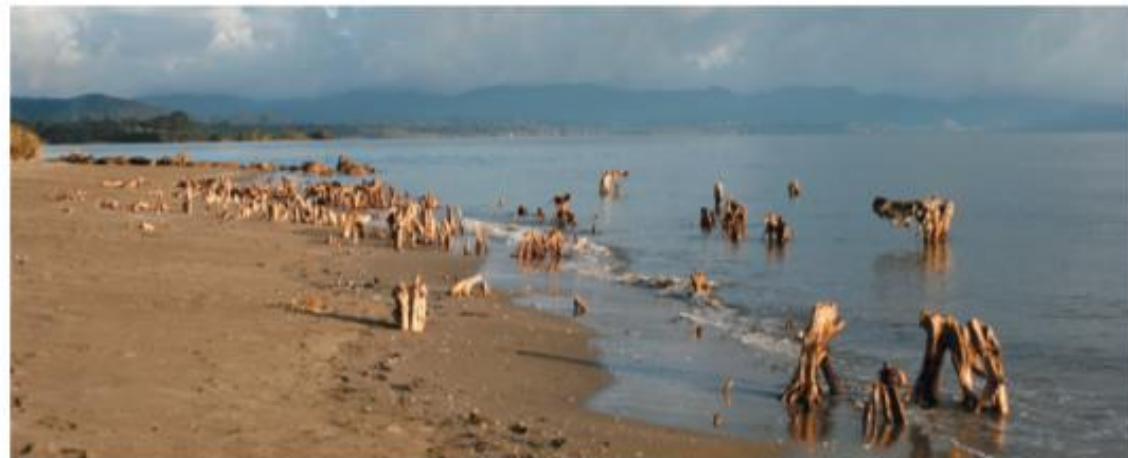
40. Inundated forests

Drowned forests have a strange melancholy appearance. Here at Rangihaeata, Golden Bay, we see trunks and roots of forest trees that grew here 8000 years ago and were killed by rising sea level at the end of the Last Ice Age. They have been buried and preserved in wet sediment and only recently exhumed by sea erosion (photo Egon Eberle, 2009).

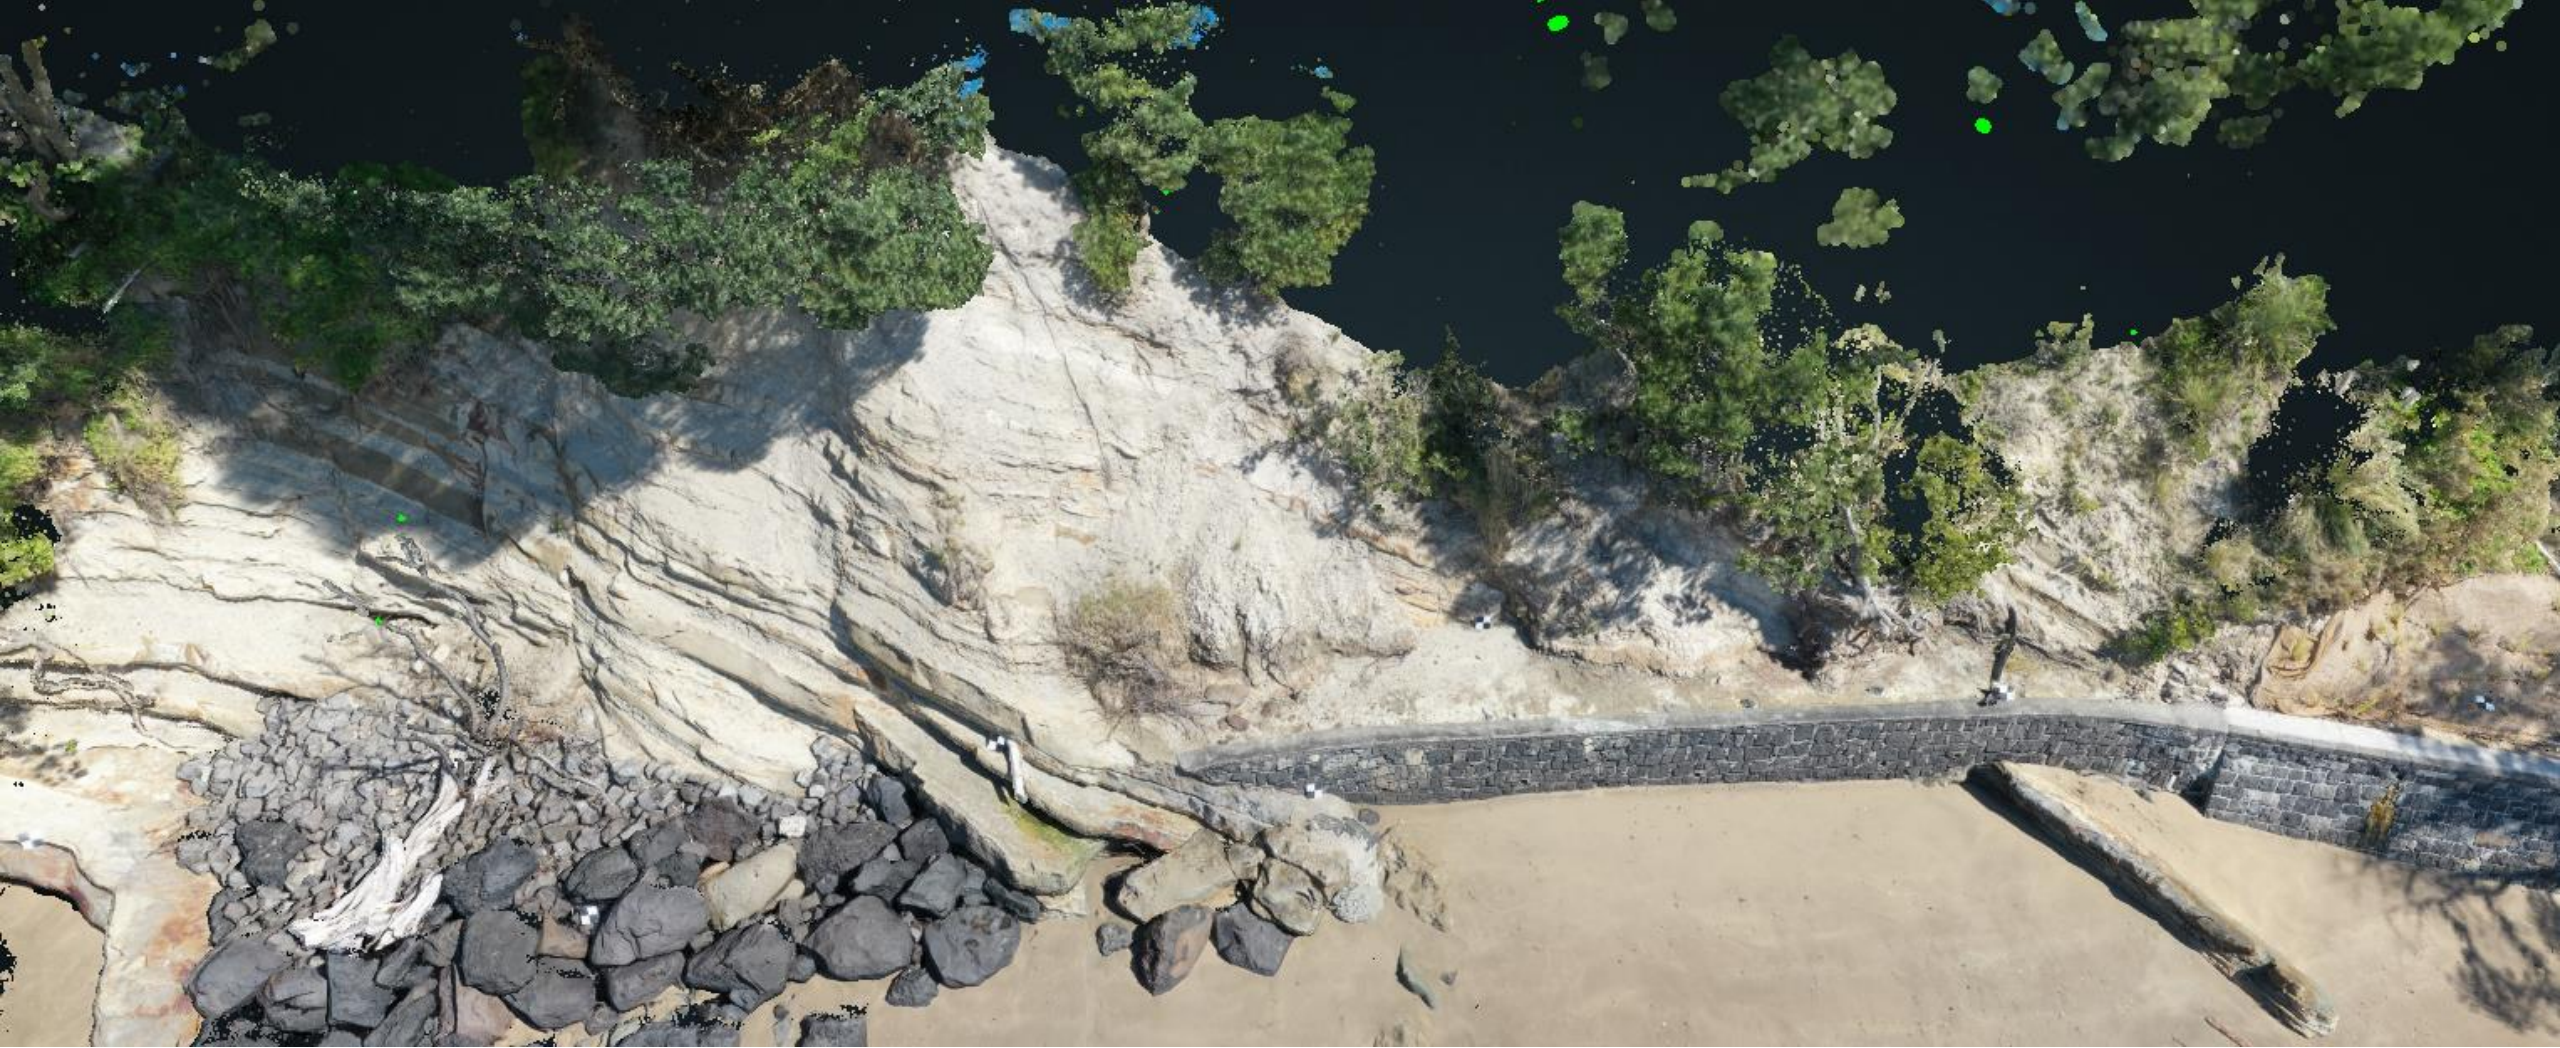
Coastal Protection from Erosion:
Large 'Armour' Basalt Boulders at the Foot of the Cliff & Seawall

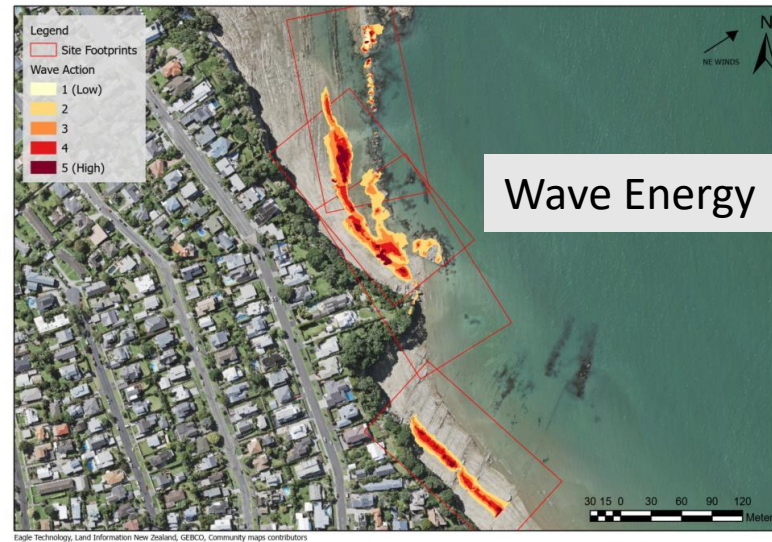
Wave energy distribution at Narrowneck Auckland NZ
